SUBJECT: Removal Site Evaluation for the Deferiet Paper Mill Site (CERCLIS #: NYD002229269), Deferiet, Jefferson County, New York

REMOVAL SITE EVALUATION FOR THE
DEFERIET PAPER MILL SITE
DEFERIET, NY
SITE ID# A26F

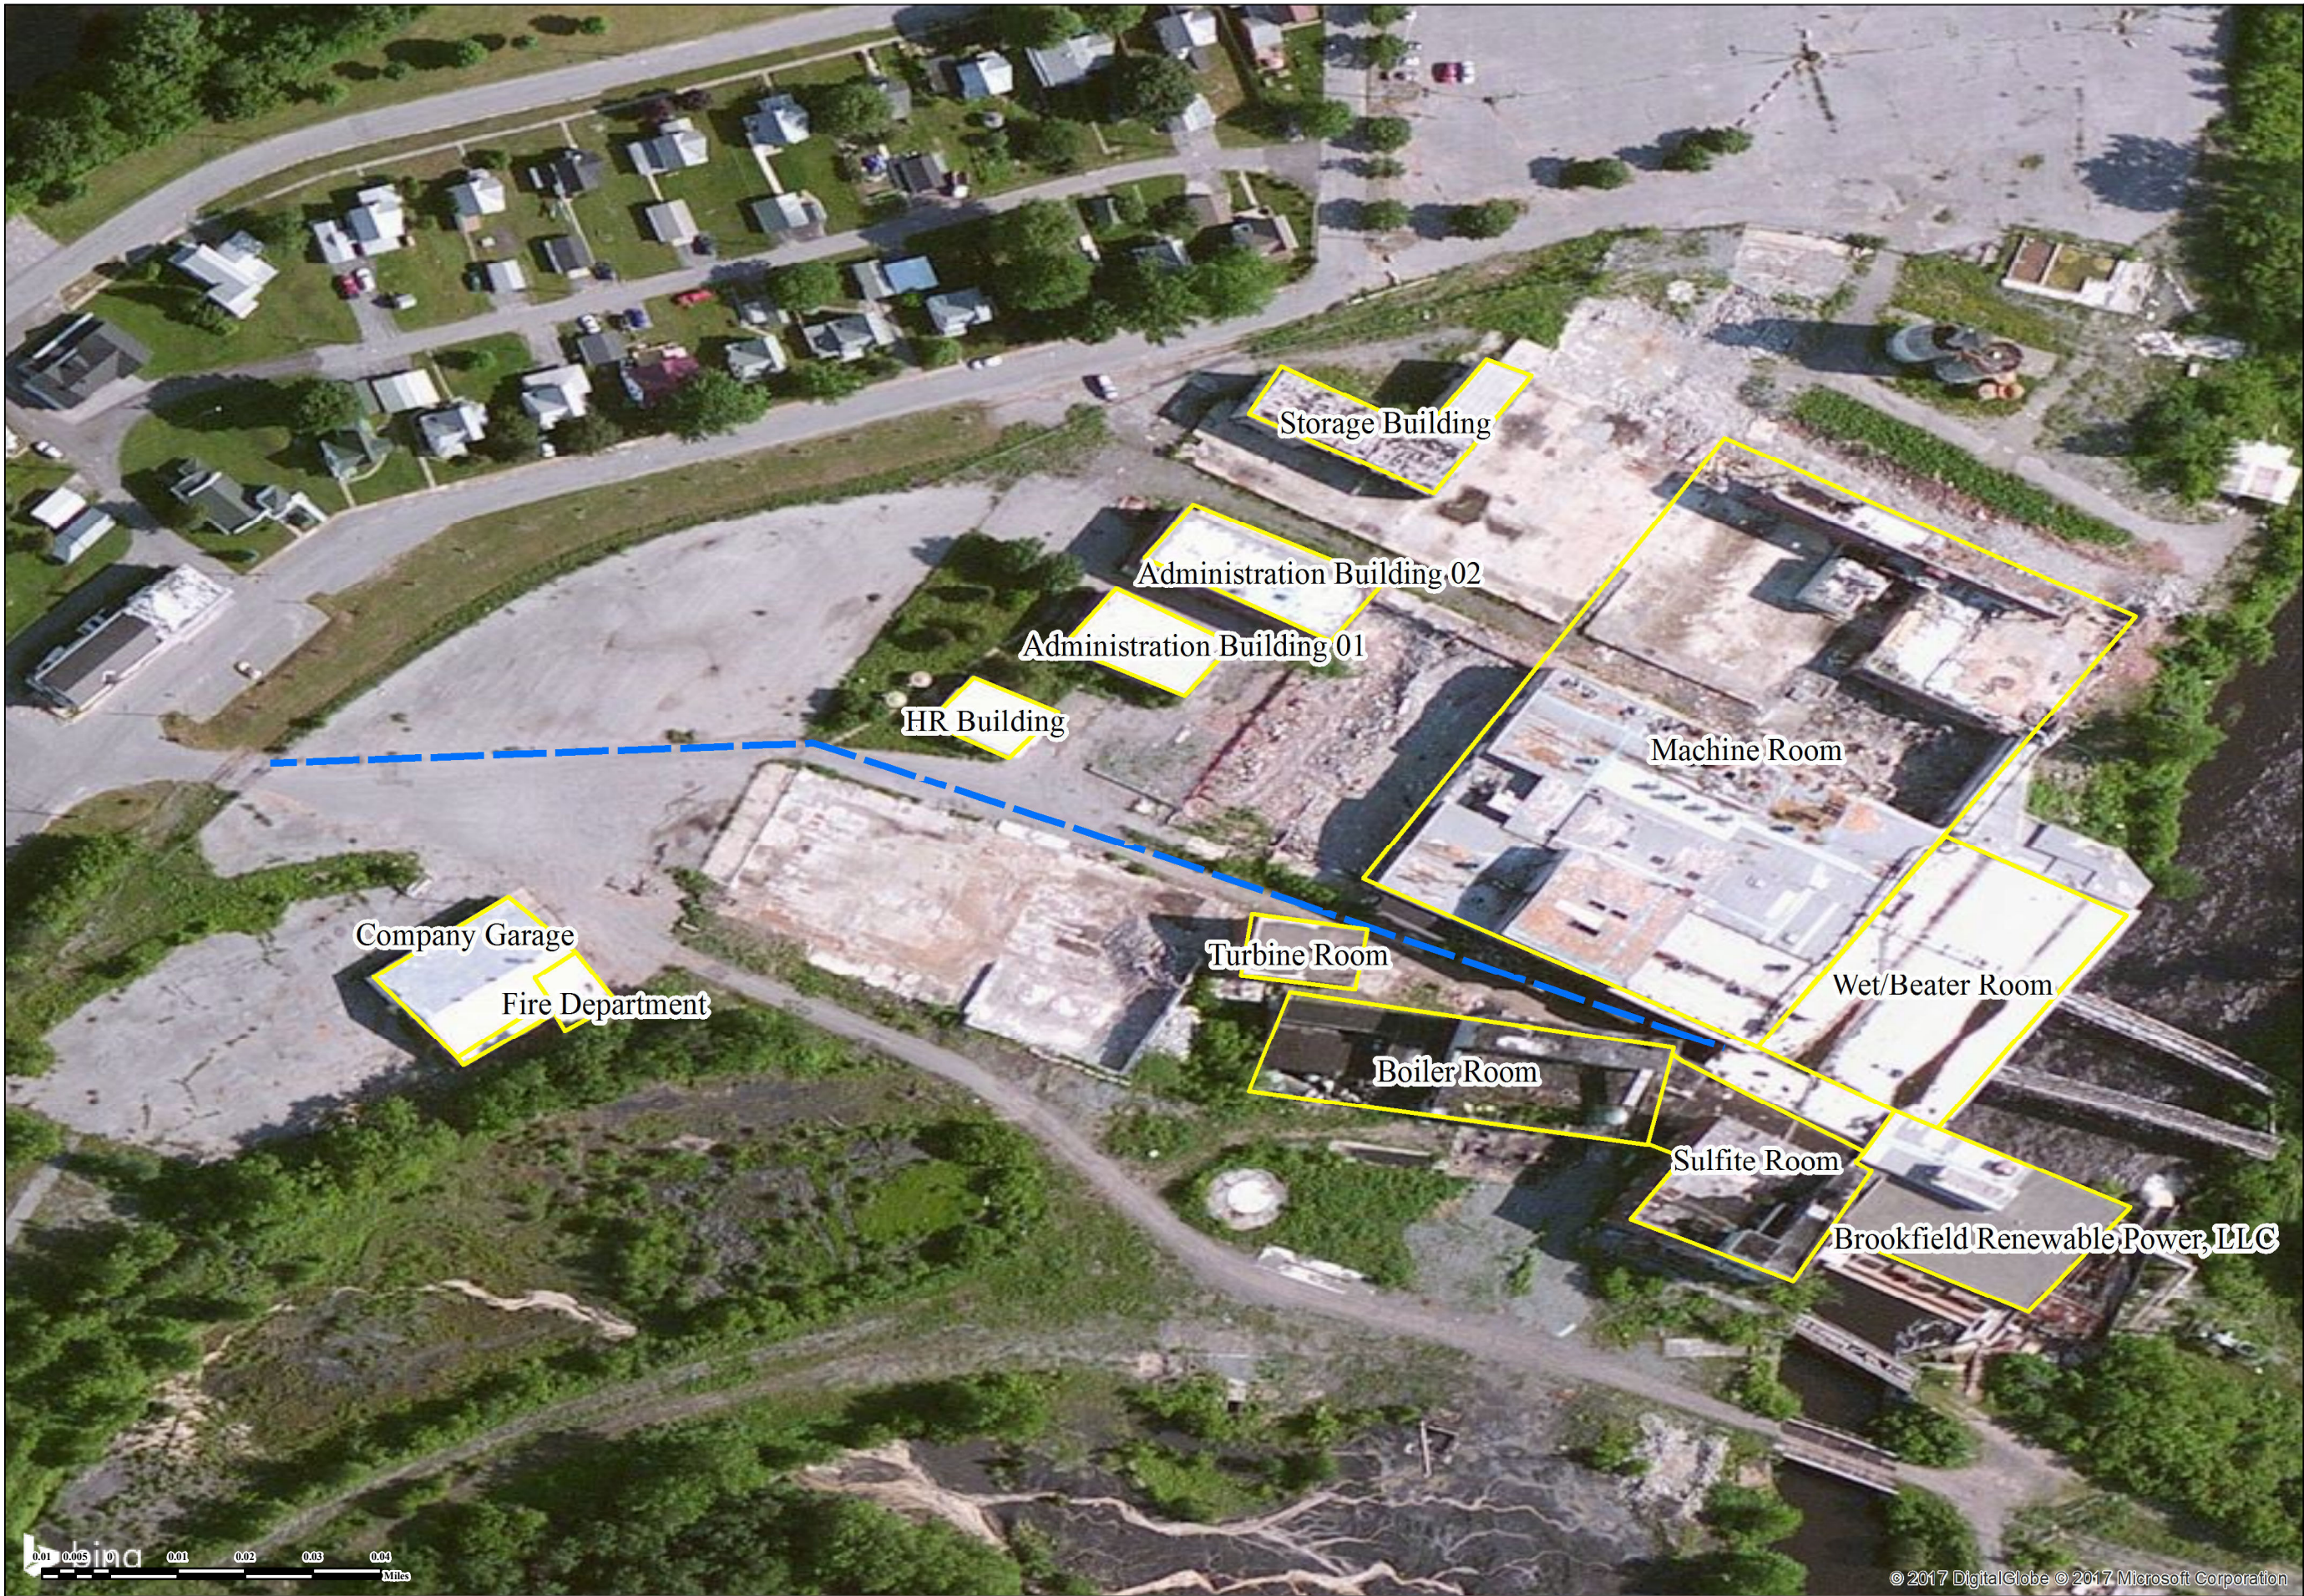
**FIGURE 2:
Site Layout Map**

1. Yard Guardhouse
2. Scaler Shack
3. Engine House
4. Sulphite Chipper Bldg.
5. Warehouses
6. Groundwood Mill
7. Sulphite Mill
8. Niagara Mohawk Power Corp.
9. Acid Plant
10. Paint Shop
11. Boilerhouse
12. Sheet Cutting & Roll Storage
13. Garage
14. 1-5 P.M. & Stock Prep. & Supercalenders
15. #6 P.M., Stockroom, Paper Storage & Coating Prep.
16. Main Office
17. Time Office
18. Mill Guardhouse
19. Water Tank

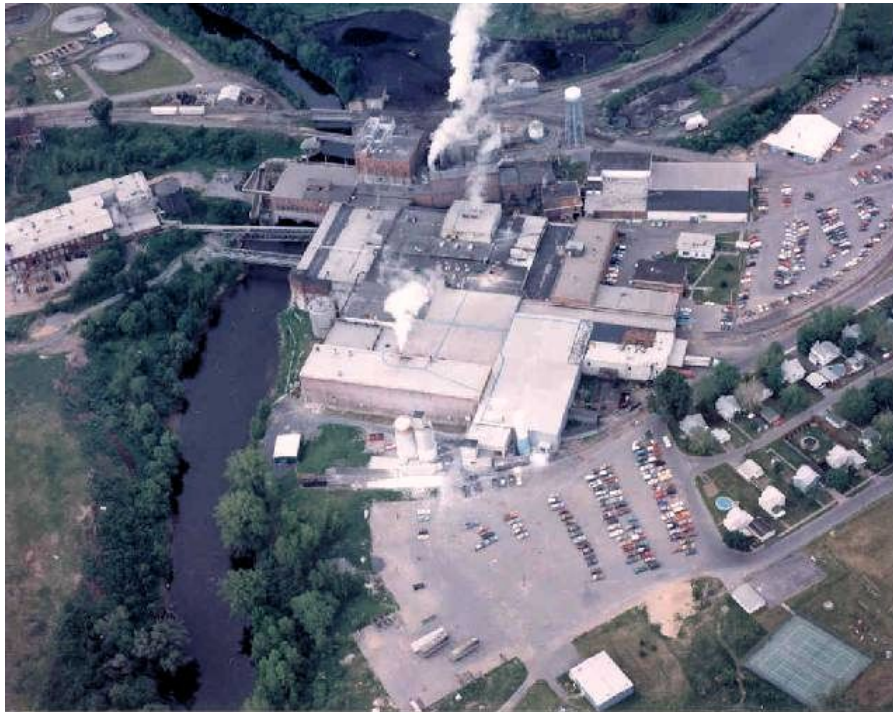
Figure 3. Aerial view of the St. Regis paper mill in operation (looking south), undated (source: Low Impact Hydro Institute, <http://www.impacthydro.org>).

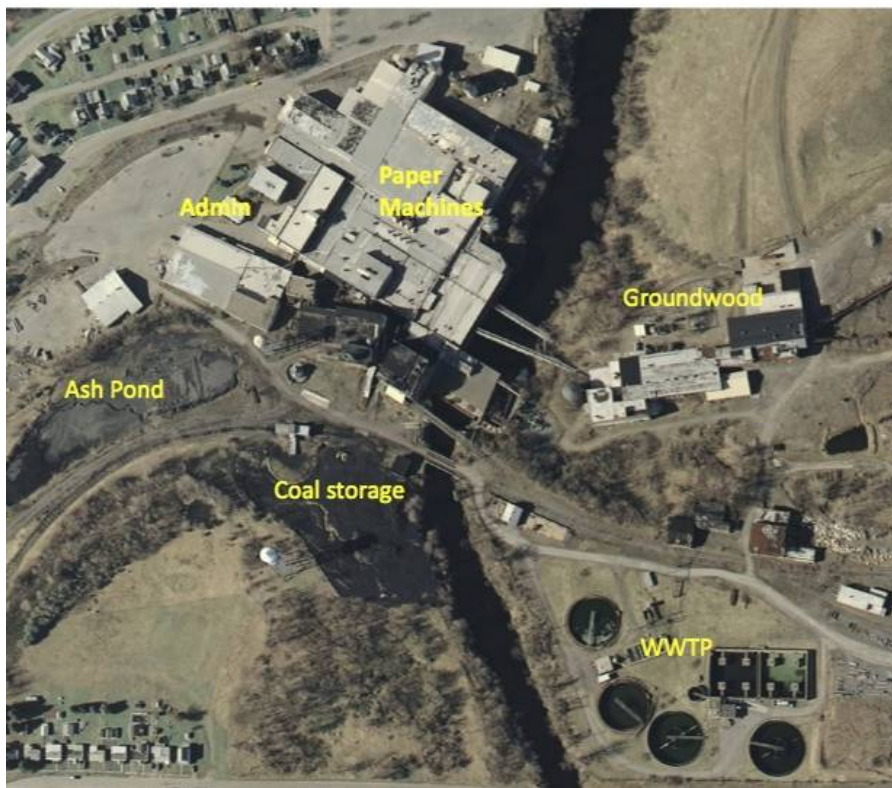
Figure 4. Annotated aerial overview (looking north).
